Technical Information BIS Yeti® Mountingsystem

Test Report
1762-001-19

- Impact Sound Reduction by Support Systems in the laboratory -

Test Object: BIS Yeti[®] Support Systems, type 480 or 335
with additional load, without or with EPS-insulation

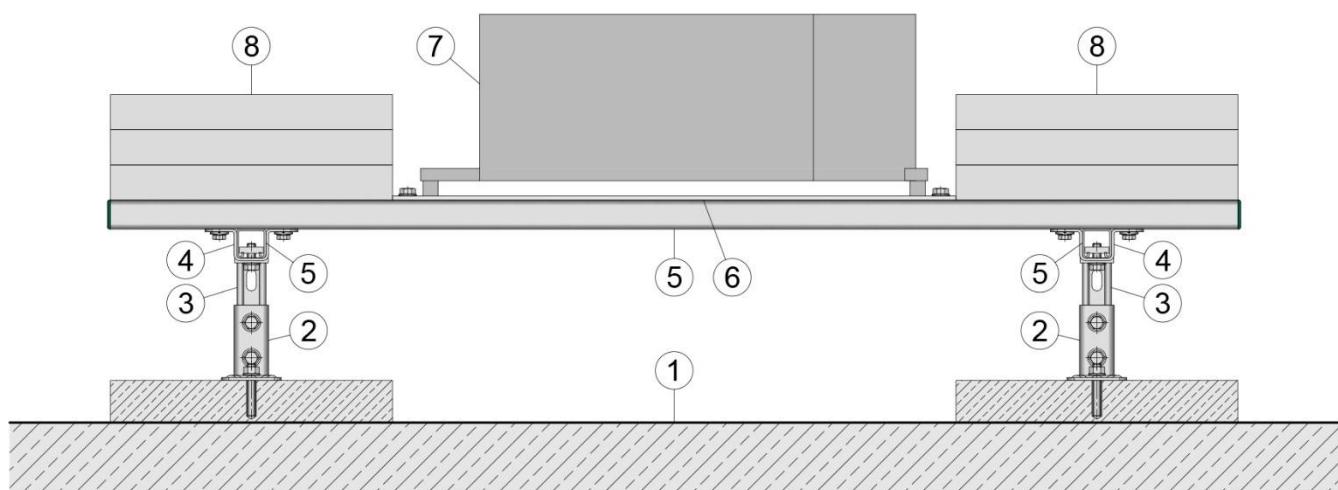
Test set-up 1: reference arrangement with rail base, 100 kg additional load per foot

| ① Messdecke | ④ Kreuzverbinder | ⑦ Norm-Hammerwerk |
| ② Schienenfuß auf Betonplatte | ⑤ C-Profil Montageschiene | ⑧ Ballastierung (Betonplatten) |
| ③ C-Profil Schienenkonsole | ⑥ Stahlplatte 800x300x6 mm | |

- Measurement 1:** **reference arrangement (set-up with concrete slabs)**
with rail base (2 pieces), placed on laboratory ceiling
appx. 100 kg additional load per foot

| Measurement 1: | concrete slabs with rail base, 100 kg load per foot | $\Delta L_w = 13 \text{ dB}$ |

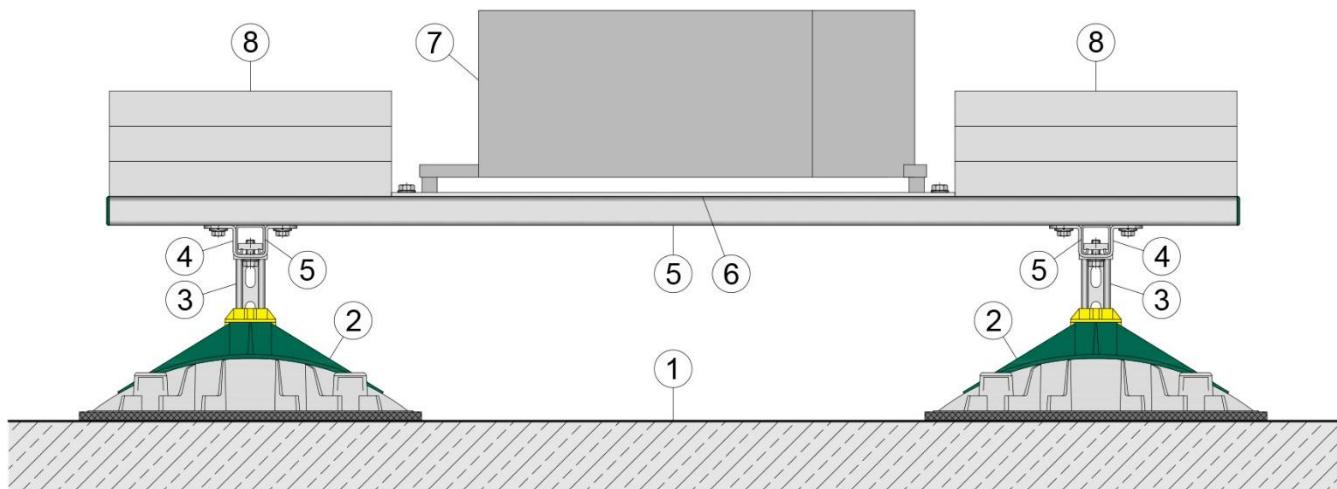
Test set-up 2: BIS Yeti® Support System, type 480, 100 kg additional load per foot

| ① Messdecke | ④ Kreuzverbinder | ⑦ Norm-Hammerwerk |
| ② BIS Yeti® 480 Montagefuß | ⑤ C-Profil Montageschiene | ⑧ Ballastierung (Betonplatten) |
| ③ C-Profil Schienenkonsole | ⑥ Stahlplatte 800x300x6 mm | |

- Measurement 2:** **BIS Yeti® Support System, type 480** (2 pieces) non-slip anti-vibration mat made of EPDM, placed on laboratory ceiling
appx. 100 kg additional load per foot

| Measurement 2: | BIS Yeti® 480, 100 kg load per foot | $\Delta L_w = 28 \text{ dB}$ |

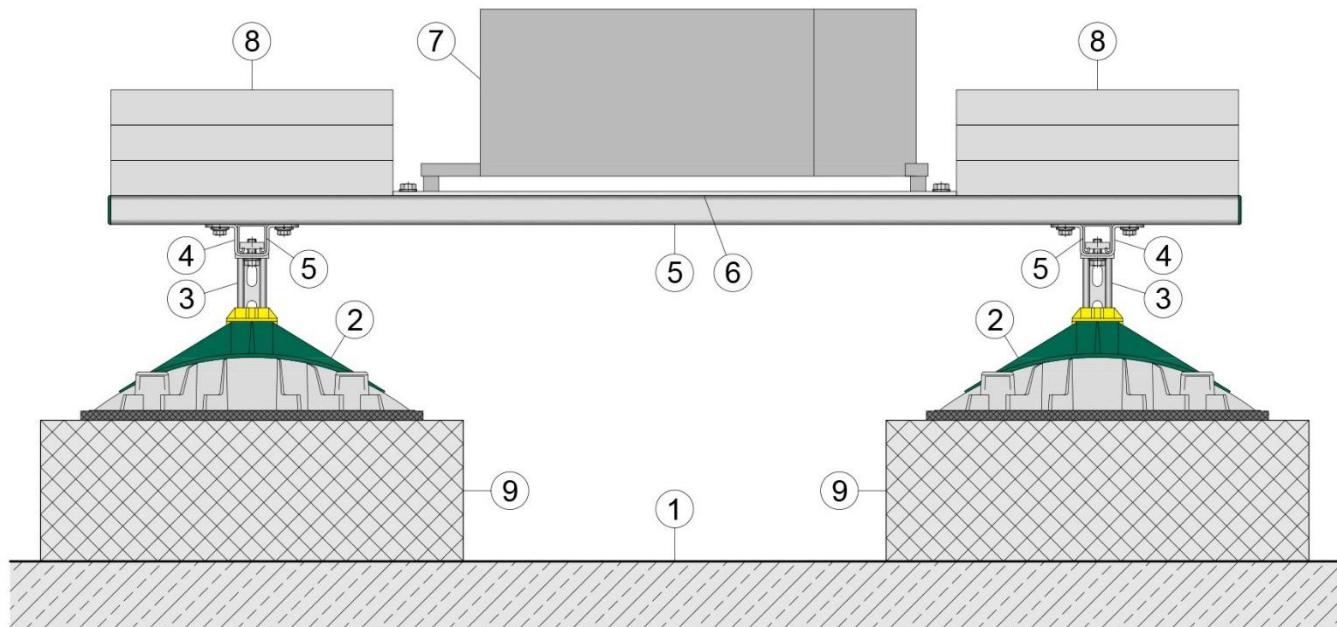
Test set-up 3/4/5: BIS Yeti® Support System, type 480, 100/200/300 kg additional load per foot, EPS-insulation

| ① Messdecke | ④ Kreuzverbinder | ⑦ Norm-Hammerwerk |
| ② BIS Yeti® 480 Montagefuß | ⑤ C-Profil Montageschiene | ⑧ Ballastierung (Betonplatten) |
| ③ C-Profil Schienenkonsole | ⑥ Stahlplatte 800x300x6 mm | ⑨ Dämmung EPS DAA dm |

- Measurement 3:** **BIS Yeti® Support System, type 480** (2 pieces) non-slip anti-vibration mat made of EPDM, **placed on EPS-insulation ($t = 200$ mm)**
appx. 100 kg additional load per foot

- Measurement 4:** **BIS Yeti® Support System, type 480** (2 pieces) non-slip anti-vibration mat made of EPDM, **placed on EPS-insulation ($t = 200$ mm)**
appx. 200 kg additional load per foot

- Measurement 5:** **BIS Yeti® Support System, type 480** (2 pieces) non-slip anti-vibration mat made of EPDM, **placed on EPS-insulation ($t = 200$ mm)**
appx. 300 kg additional load per foot

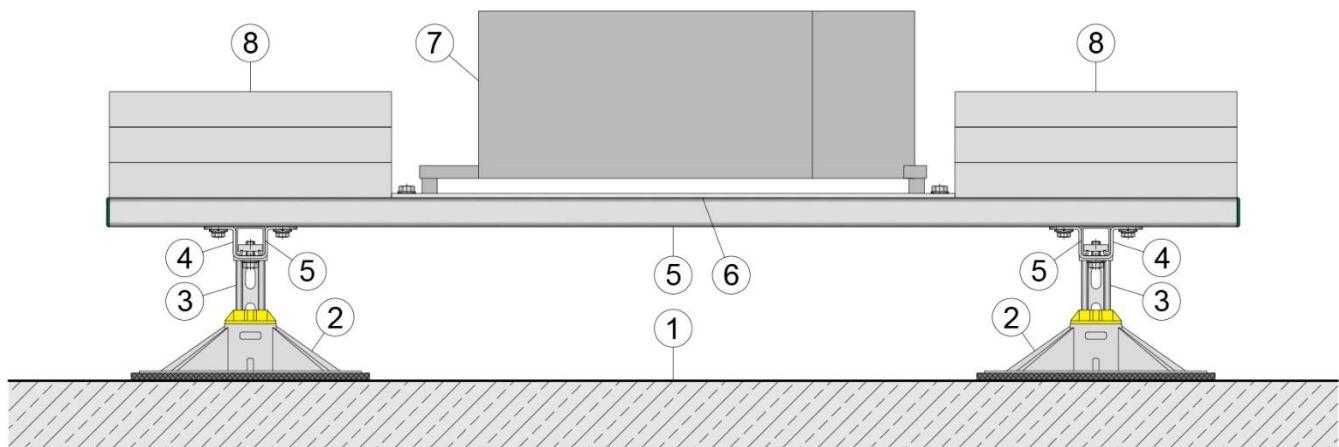
Test set-up 6: BIS Yeti® Support System, type 335, 100 kg additional load per foot

| ① Messdecke | ④ Kreuzverbinder | ⑦ Norm-Hammerwerk |
| ② BIS Yeti® 335 Montagefuß | ⑤ C-Profil Montageschiene | ⑧ Ballastierung (Betonplatten) |
| ③ C-Profil Schienenkonsole | ⑥ Stahlplatte 800x300x6 mm | |

| Measurement 6: | BIS Yeti® 335, 100 kg load per foot | $\Delta L_w = 22 \text{ dB}$ |

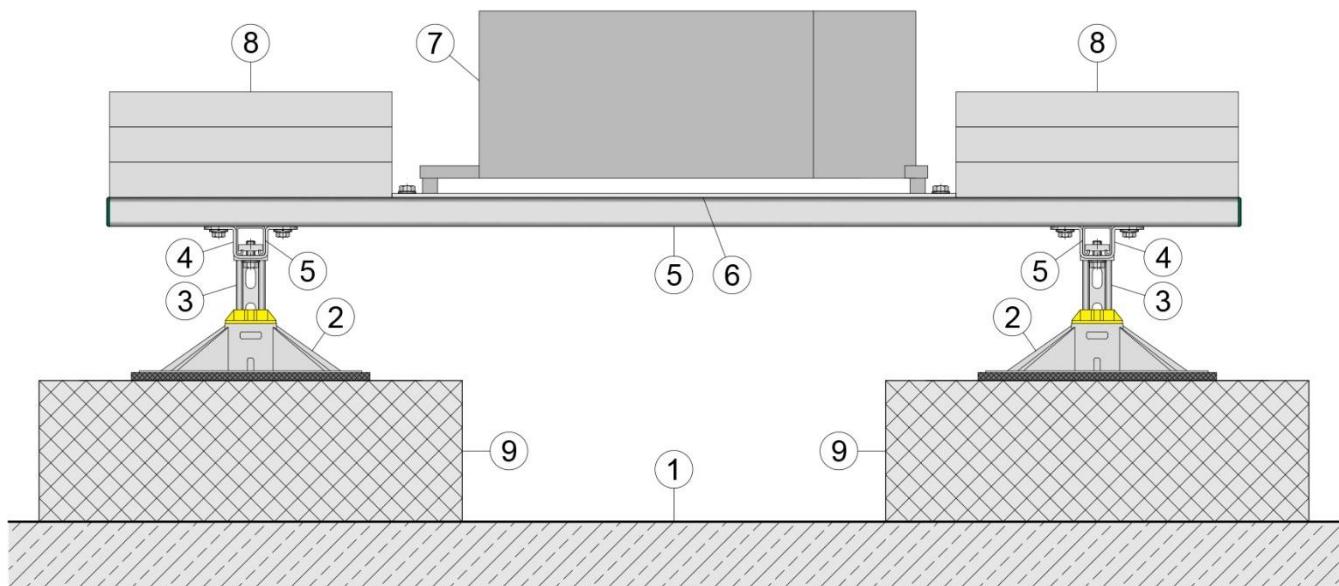
Test set-up 7/8/9: BIS Yeti® Support System, type 335, 100/200/300 kg additional load per foot, EPS-insulation

| ① Messdecke | ④ Kreuzverbinder | ⑦ Norm-Hammerwerk |
| ② BIS Yeti® 335 Montagefuß | ⑤ C-Profil Montageschiene | ⑧ Ballastierung (Betonplatten) |
| ③ C-Profil Schienenkonsole | ⑥ Stahlplatte 800x300x6 mm | ⑨ Dämmung EPS DAA dm |

| Measurement 7: | BIS Yeti® 335, 100 kg load per foot, EPS-insulation | $\Delta L_w = 29 \text{ dB}$ |
| Measurement 8: | BIS Yeti® 335, 200 kg load per foot, EPS-insulation | $\Delta L_w = 29 \text{ dB}$ |
| Measurement 9: | BIS Yeti® 335, 300 kg load per foot, EPS-insulation | $\Delta L_w = 30 \text{ dB}$ |

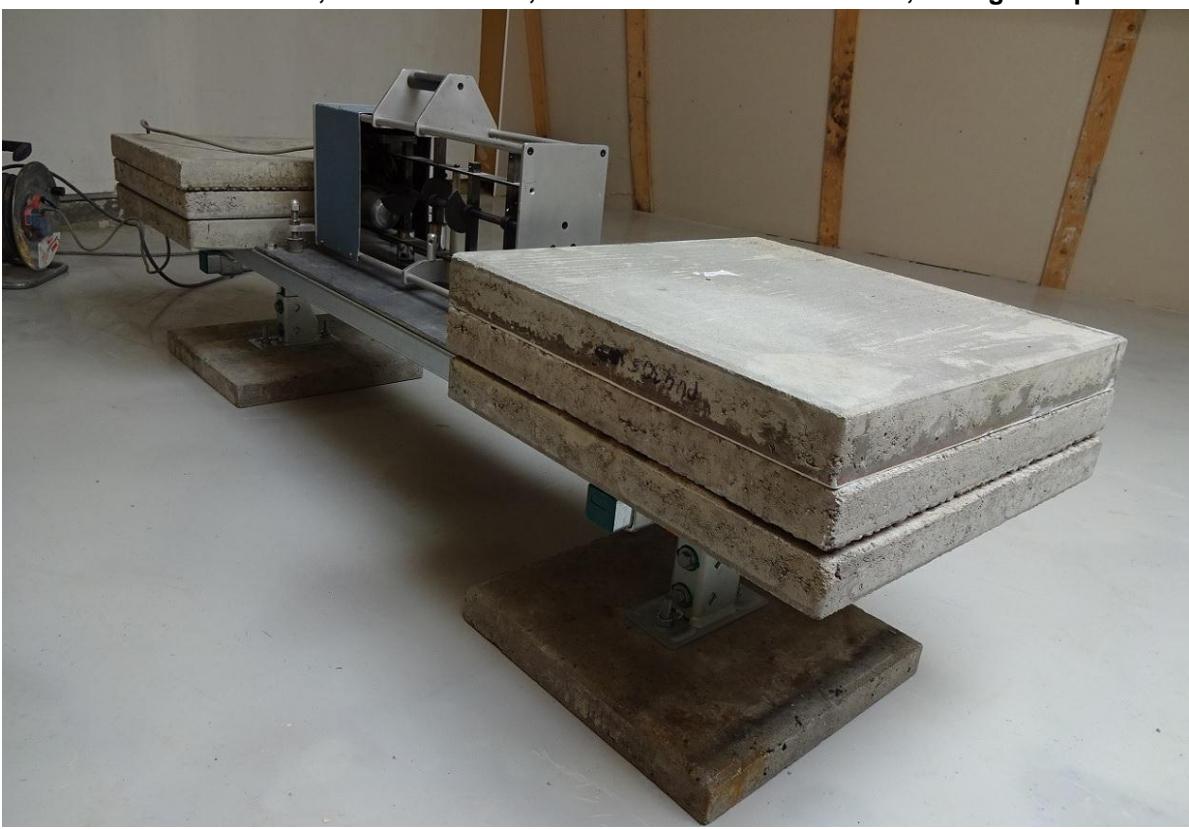
Photo 2: Reference construction, measurement 1, concrete slabs with rail base, 100 kg load per foot

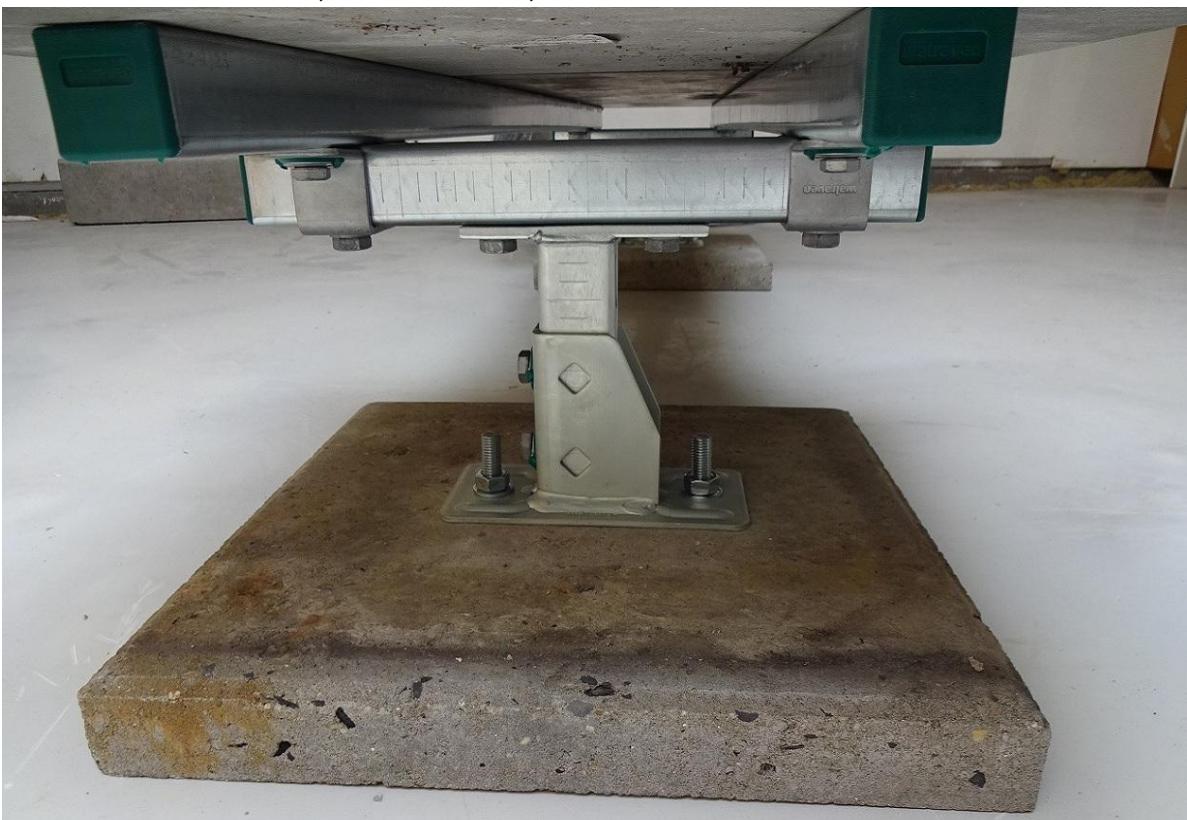
Photo 3: Reference construction, measurement 1, detail concrete slabs with rail base

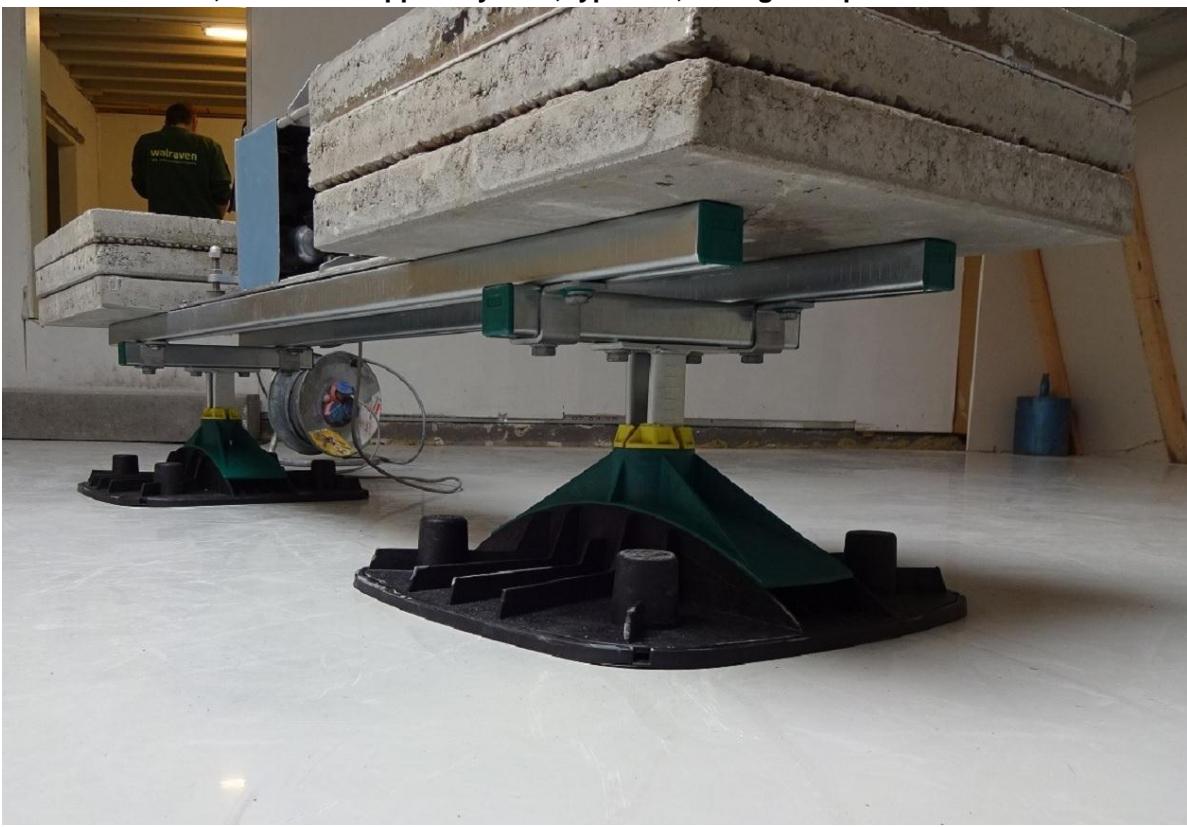
Photo 4: Measurement 2, BIS Yeti® Support System, type 480, 100 kg load per foot

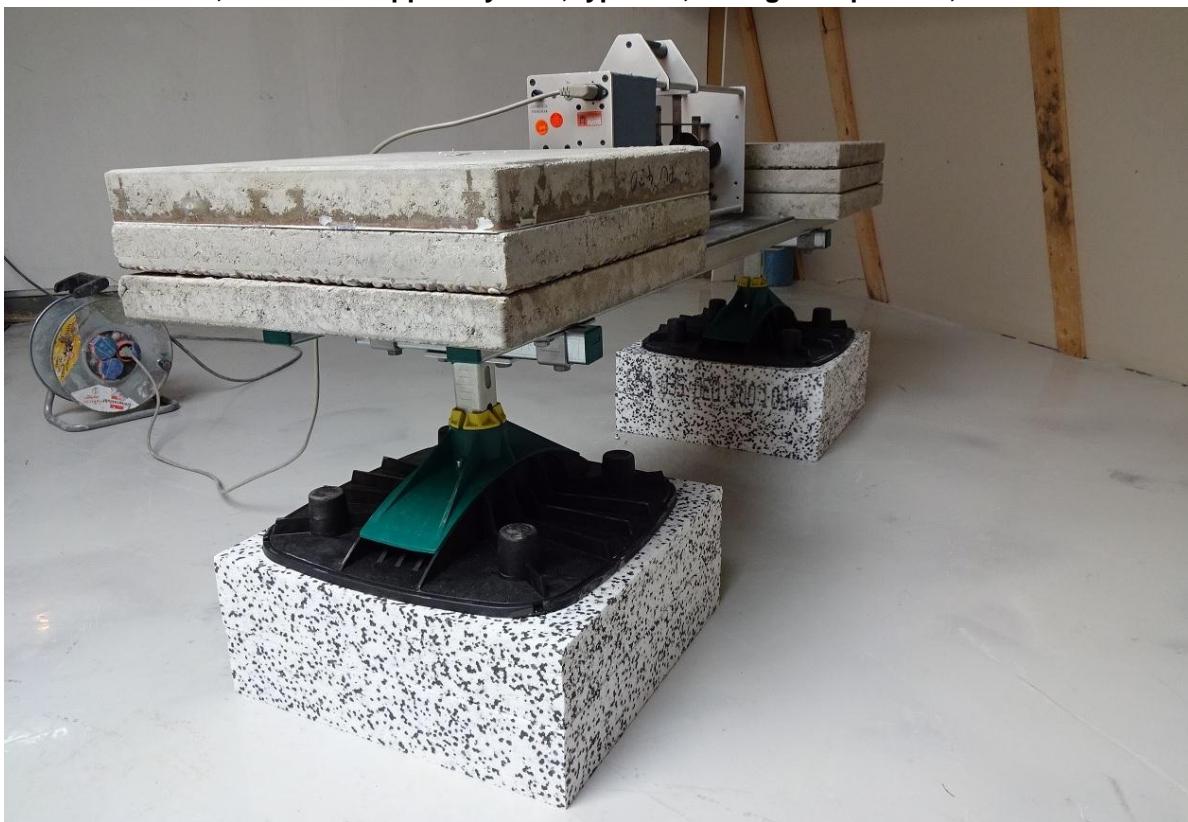
Photo 5: Measurement 3, BIS Yeti® Support System, type 480, 100 kg load per foot, with EPS-insulation

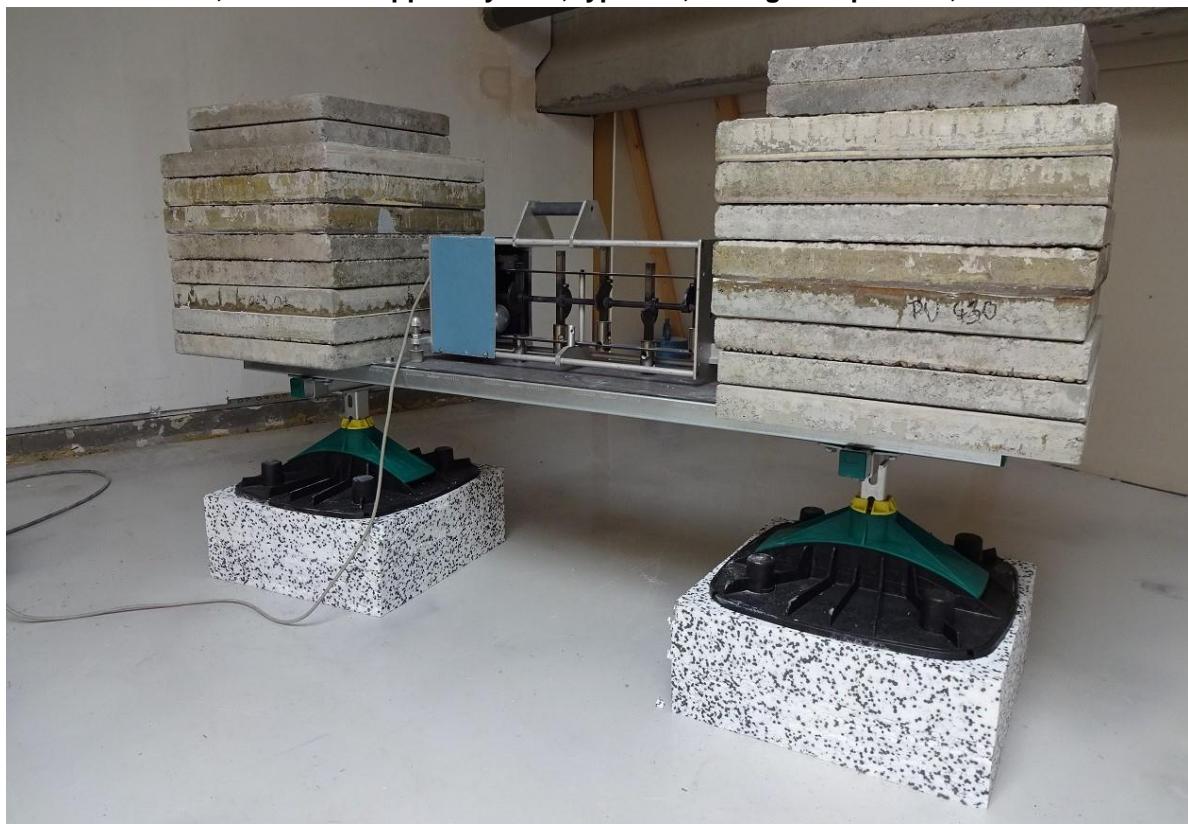
Photo 6: Measurement 5, BIS Yeti® Support System, type 480, 300 kg load per foot, with EPS-insulation

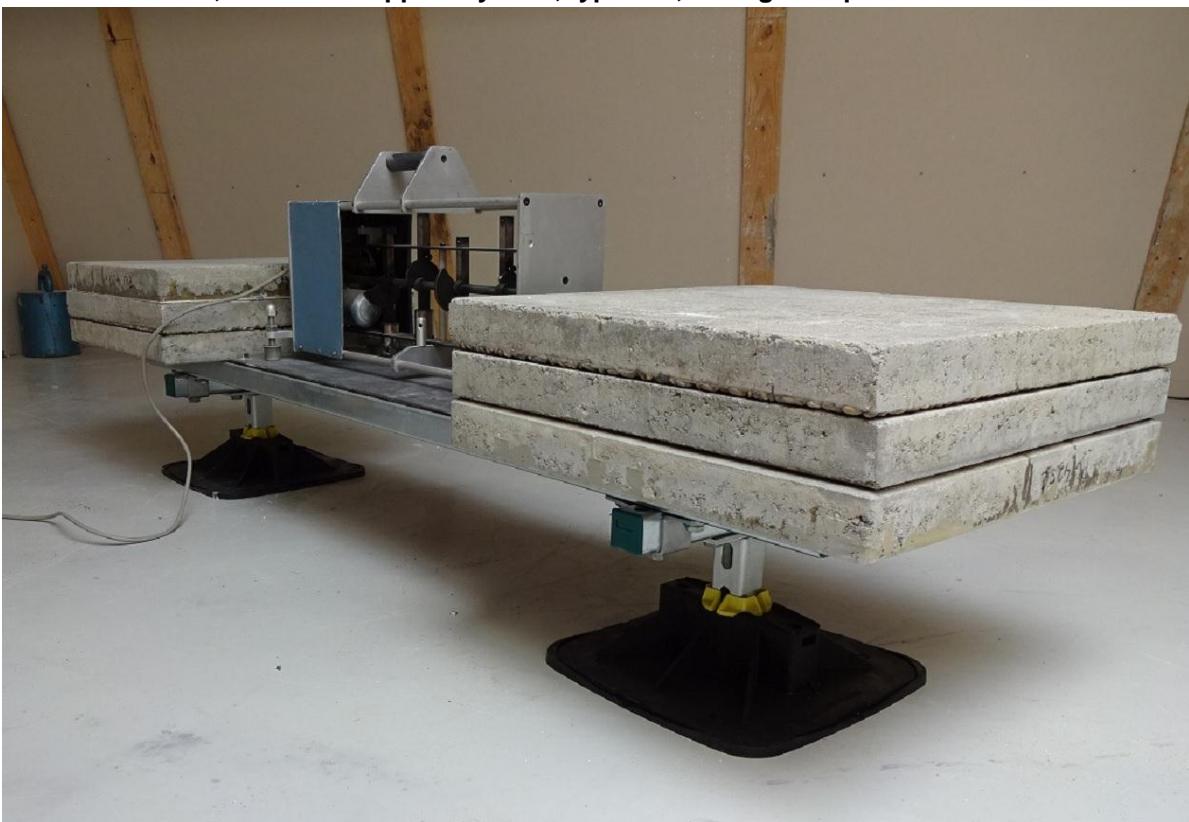
Photo 7: Measurement 6, BIS Yeti® Support System, type 335, 100 kg load per foot

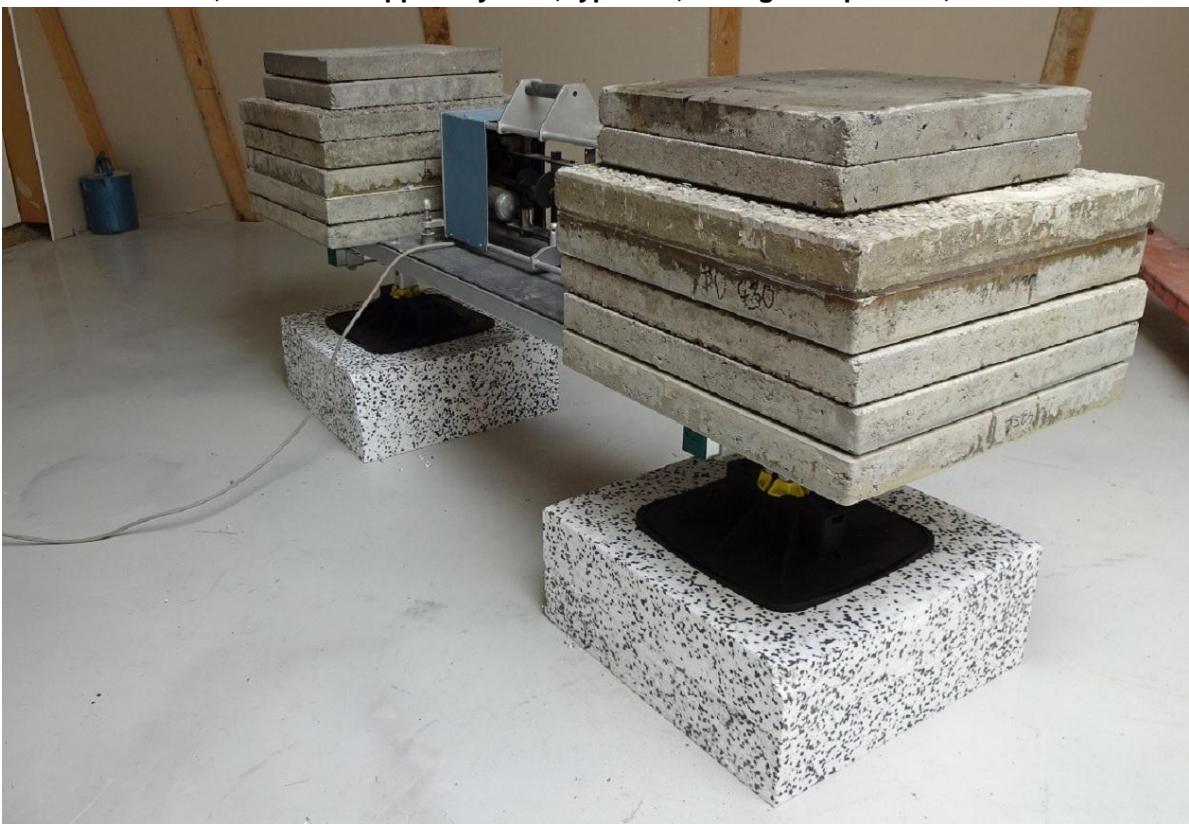
Photo 8: Measurement 8, BIS Yeti® Support System, type 335, 200 kg load per foot, with EPS-insulation

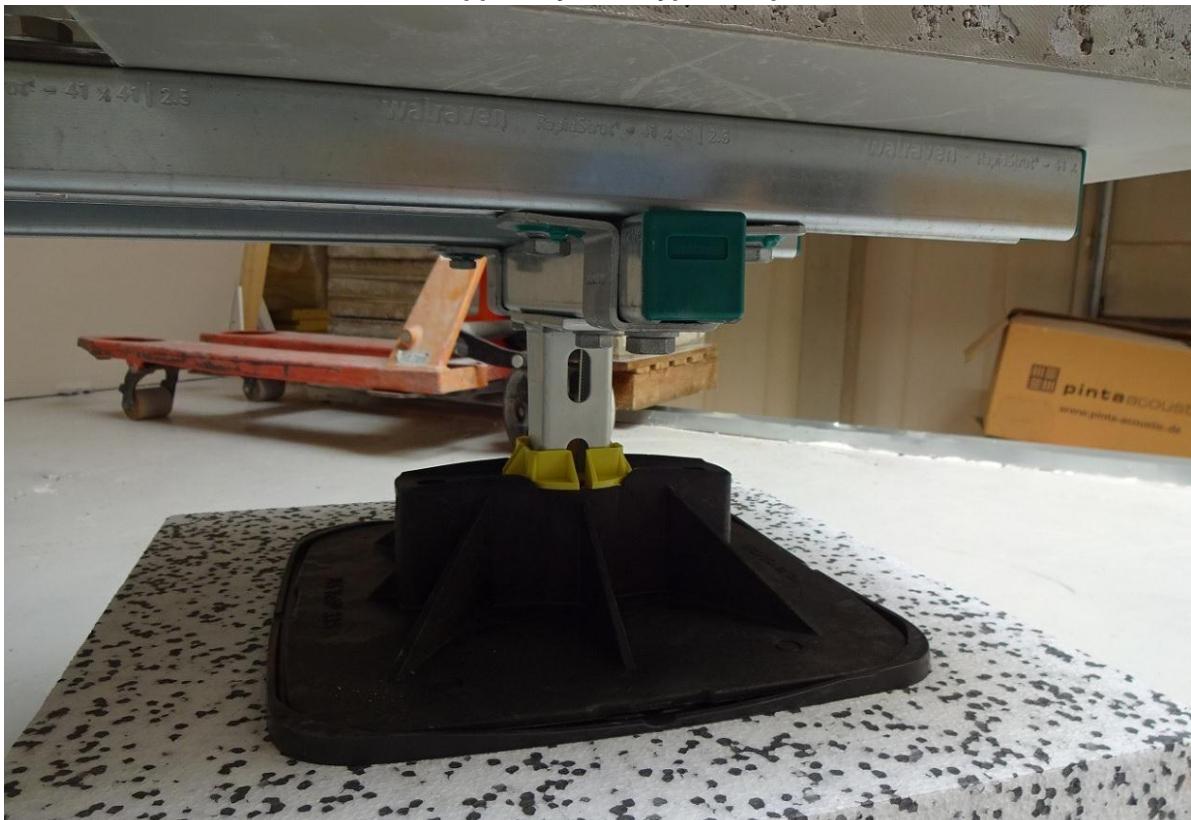
Photo 9: Measurement 7, detail BIS Yeti® Support System, type 335, placed on EPS-insulation

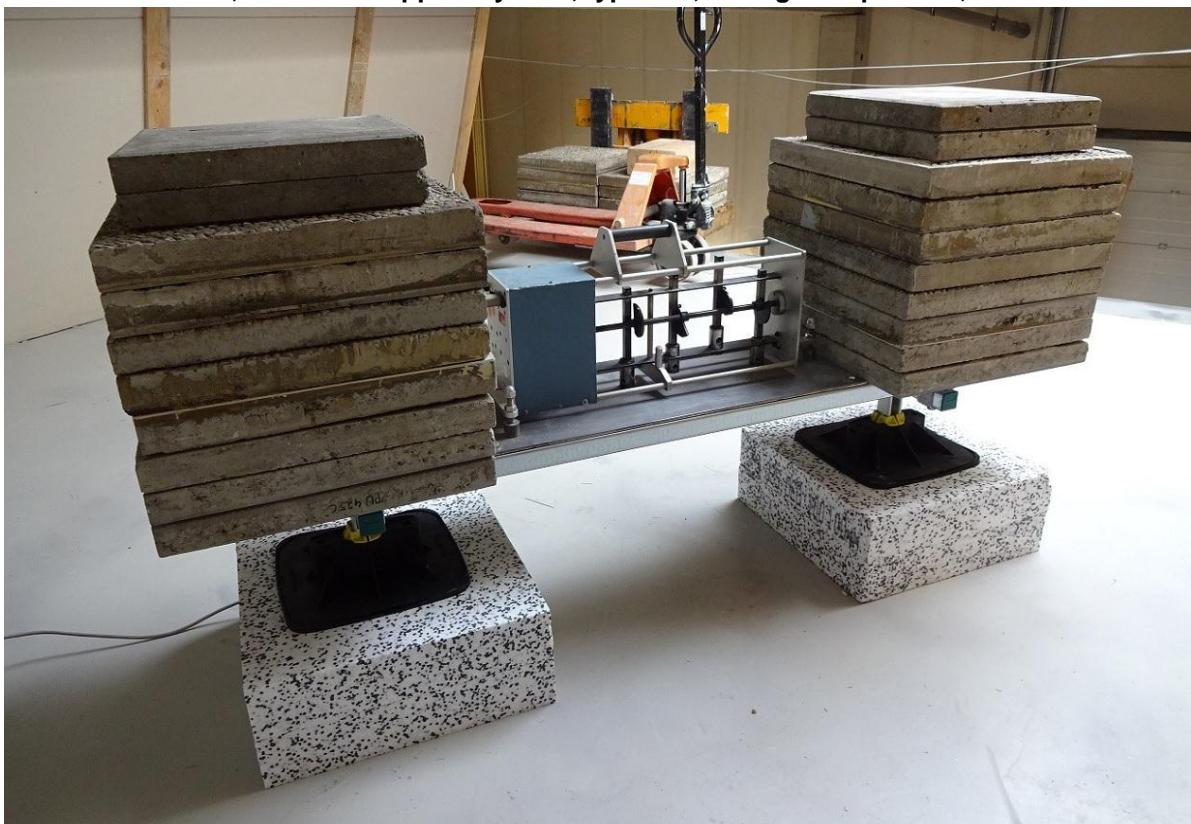
Photo 10: Measurement 9, BIS Yeti® Support System, type 335, 300 kg load per foot, with EPS-insulation

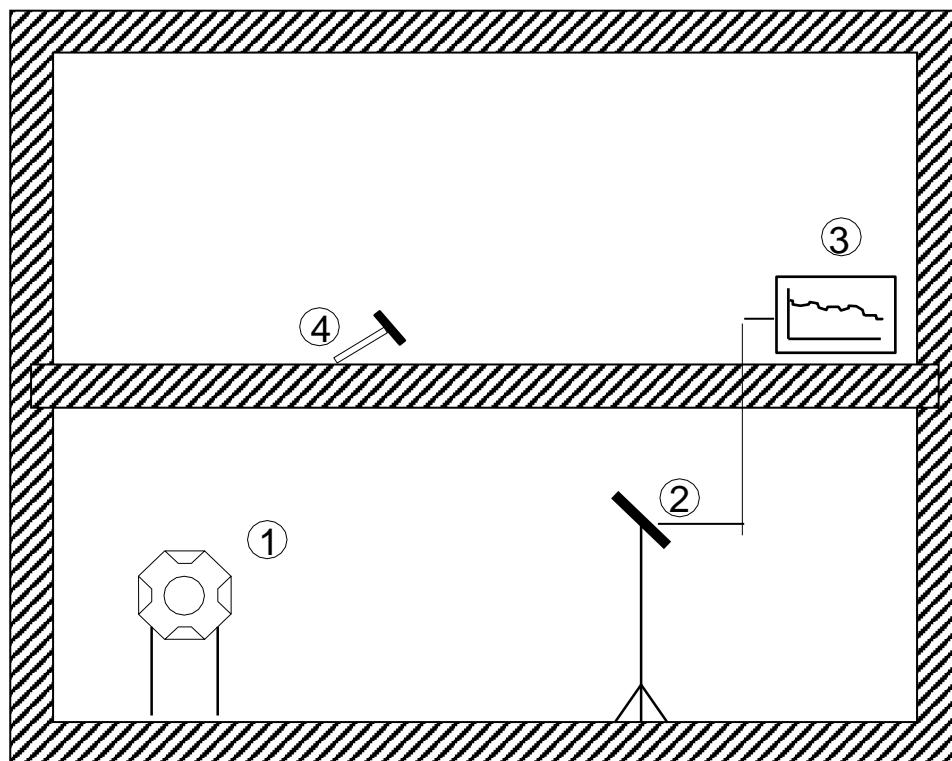
1. Measuring Set-up

In order to ascertain the standard impact sound level in accordance with DIN EN ISO 10140-3 a standard tapping machine is used to stimulate the test object in the source room. The sound pressure level generated in the receiving room is measured and averaged at a total of 3 measuring positions. Taking the reverberation time and/or the sound absorption area A in the receiving room into consideration, the standard impact sound level is ascertained in accordance with the relationships given in DIN EN ISO 10140-3. The difference of the standard impact sound level of the raw ceiling and the test set-up represents the impact sound reduction ΔL . The single value specification ΔL_w is the result of converting the measured values with due regard to the standard impact sound level of a reference ceiling according to the procedure described in DIN EN ISO 717-2.

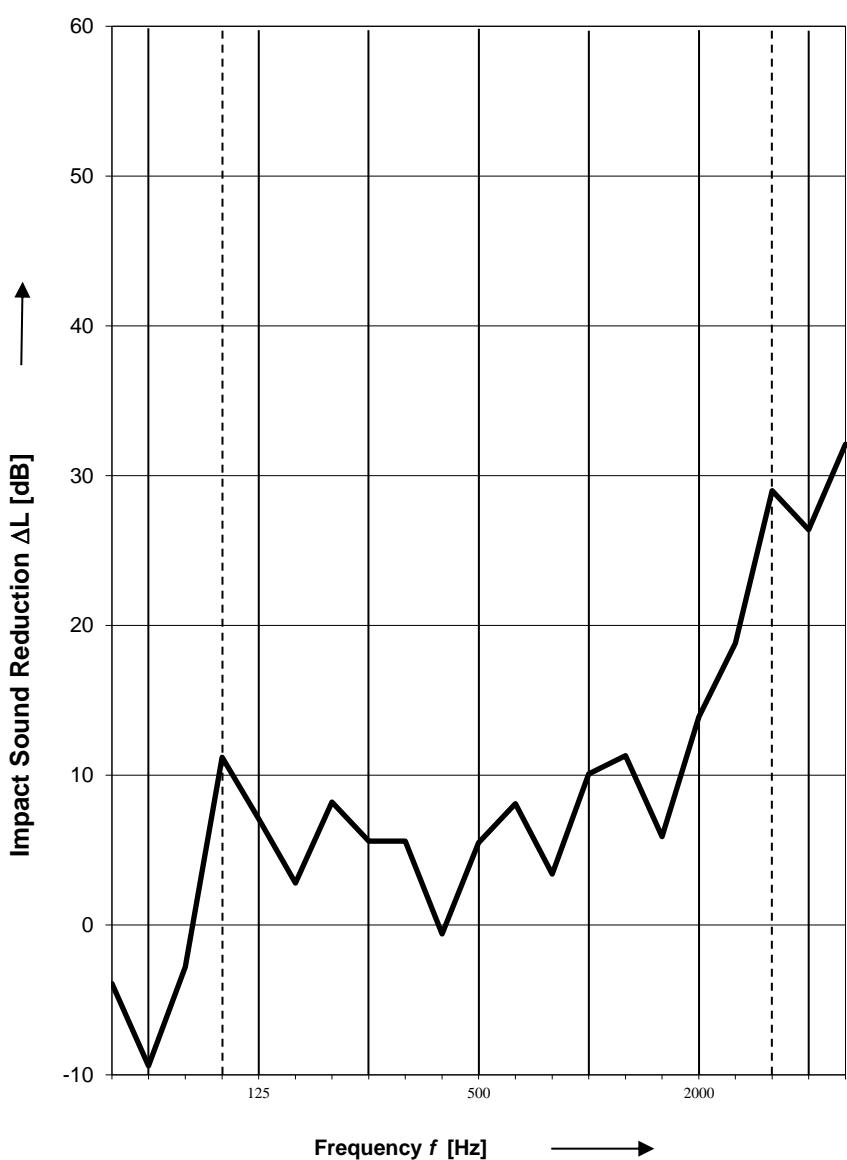
Annex 10

Description of Test Object: **Measurement 1**

Reference arrangement consisting of **concrete slabs** (400 mm x 400 mm x 50 mm) with rail base (2 pieces), horizontal support construction made of profile rails type BIS RapidStrut®, bolted steel plate (800 mm x 300 mm x 6 mm) to place on the standard tapping machine, arrangement placed on the laboratory ceiling, **approx. 100 kg additional load per foot** (approx. 200 kg total load)

Evaluation according to ISO 717-2:

| $\Delta L_w =$ | 13 dB | $\Delta L_{IN} =$ | 4 dB |
| $C_{I,\Delta} =$ | - 9 dB | $C_{I,r} =$ | - 2 dB |

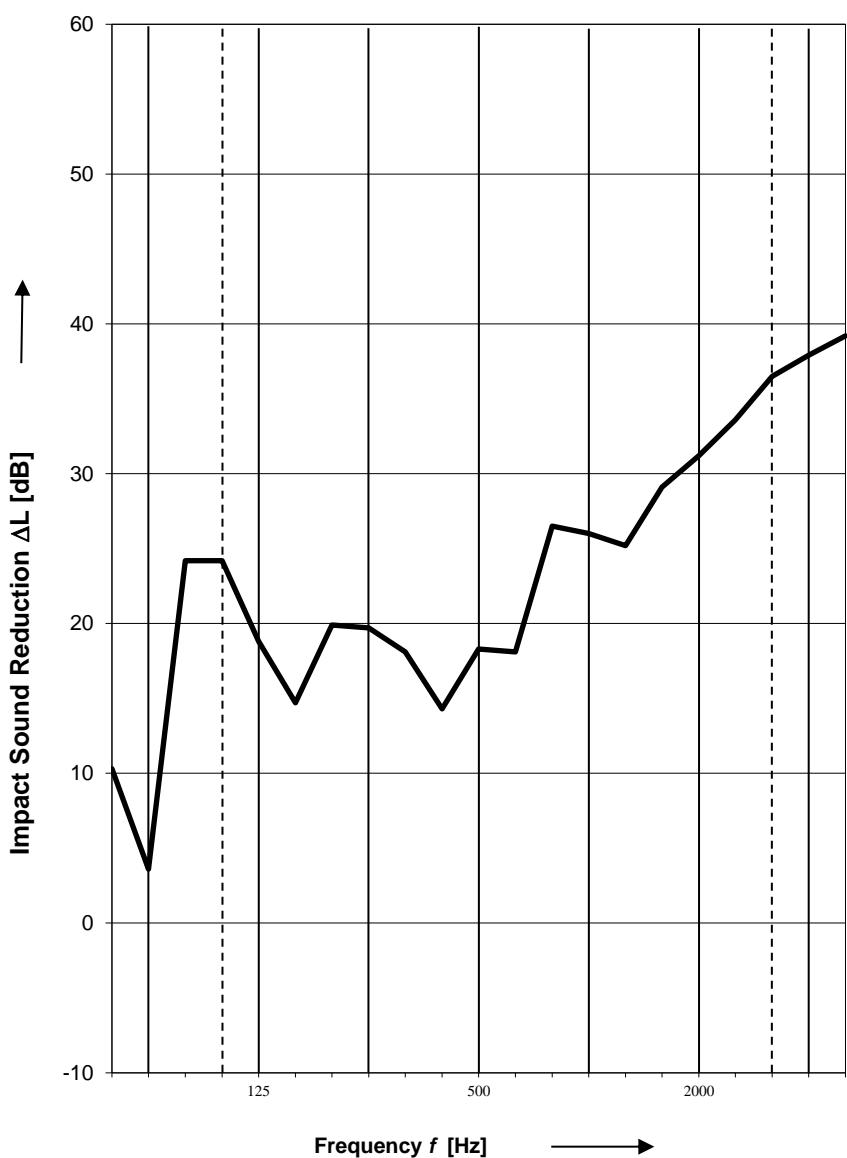
Annex 11

Description of Test Object: **Measurement 2**

Test arrangement consisting of **BIS Yeti® Support System, type 480** (2 pieces) with non-slip anti-vibration mat made of EPDM and profile rail foot, horizontal support construction made of profile rails type BIS RapidStrut®, bolted steel plate (800 mm x 300 mm x 6 mm) to place on the standard tapping machine, arrangement placed on the laboratory ceiling, **approx. 100 kg additional load per foot** (approx. 200 kg total load)

Evaluation according to ISO 717-2:

| $\Delta L_w =$ | 28 dB | $\Delta L_{IN} =$ | 19 dB |
| $C_{I,\Delta} =$ | - 9 dB | $C_{I,r} =$ | - 2 dB |

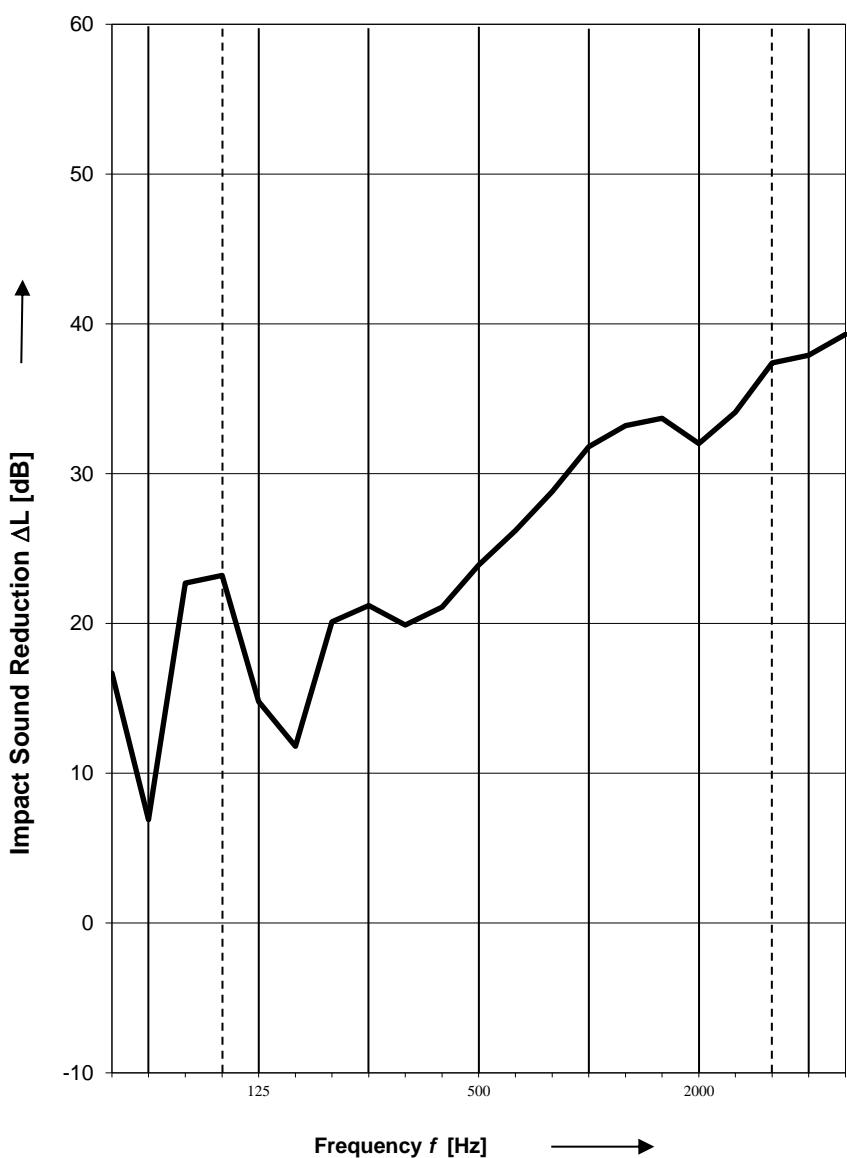
Annex 12

Evaluation according to ISO 717-2:

| $\Delta L_w =$ | 31 dB | $\Delta L_{IN} =$ | 20 dB |

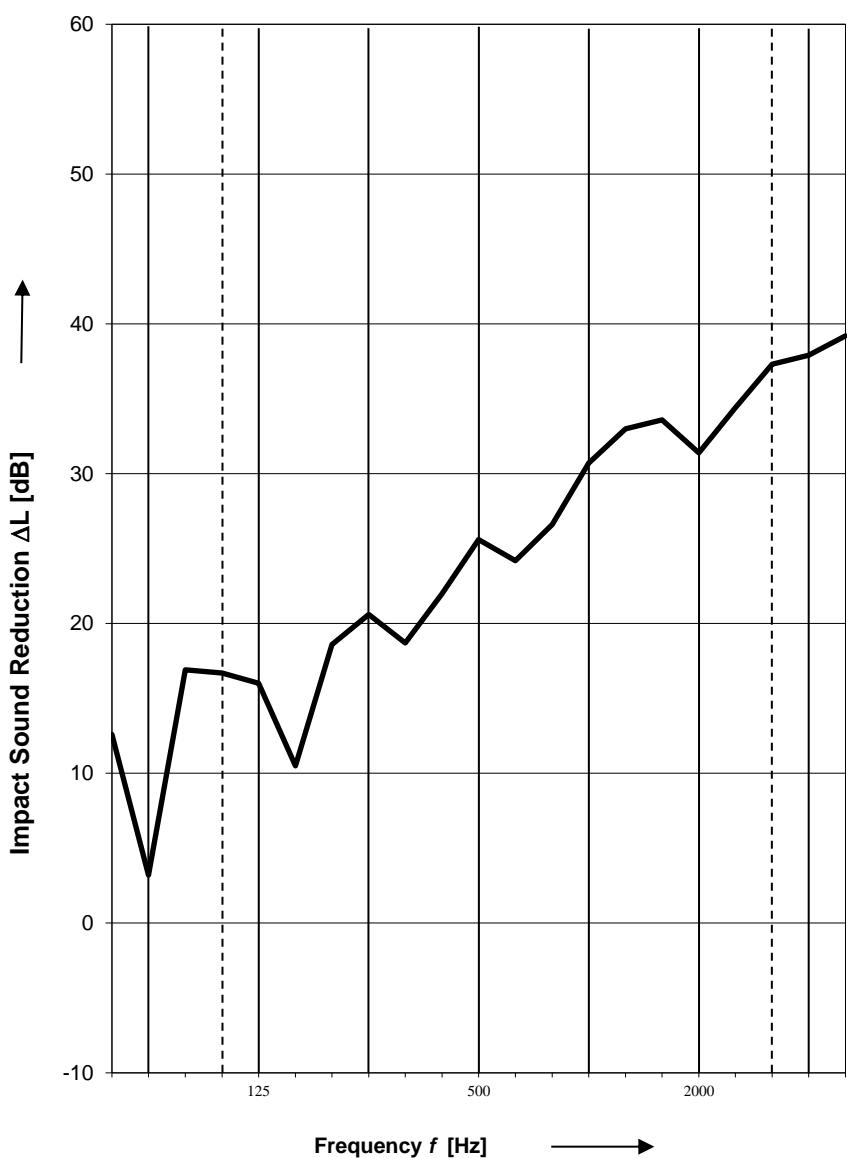
Evaluation according to ISO 717-2:

| $\Delta L_w =$ | 30 dB | $\Delta L_{IN} =$ | 20 dB |

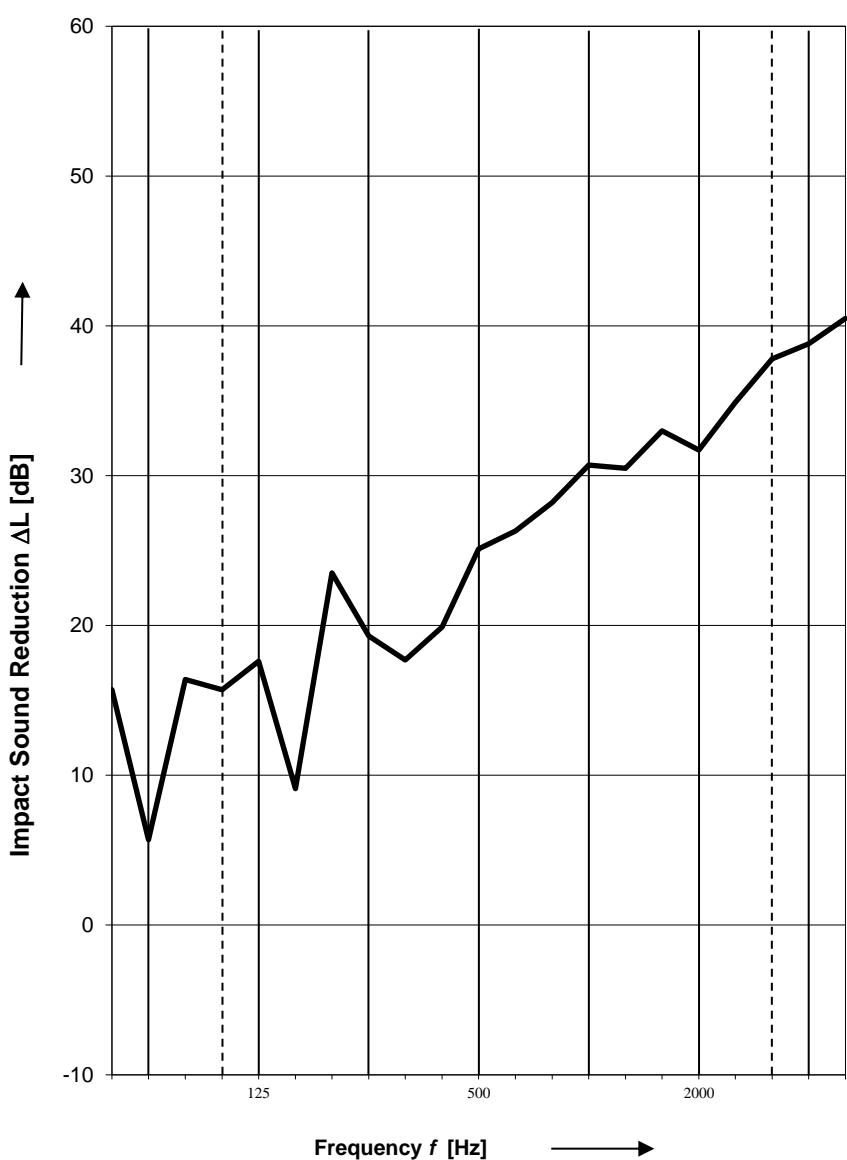
Evaluation according to ISO 717-2:

| $\Delta L_w =$ | 30 dB | $\Delta L_{IN} =$ | 19 dB |

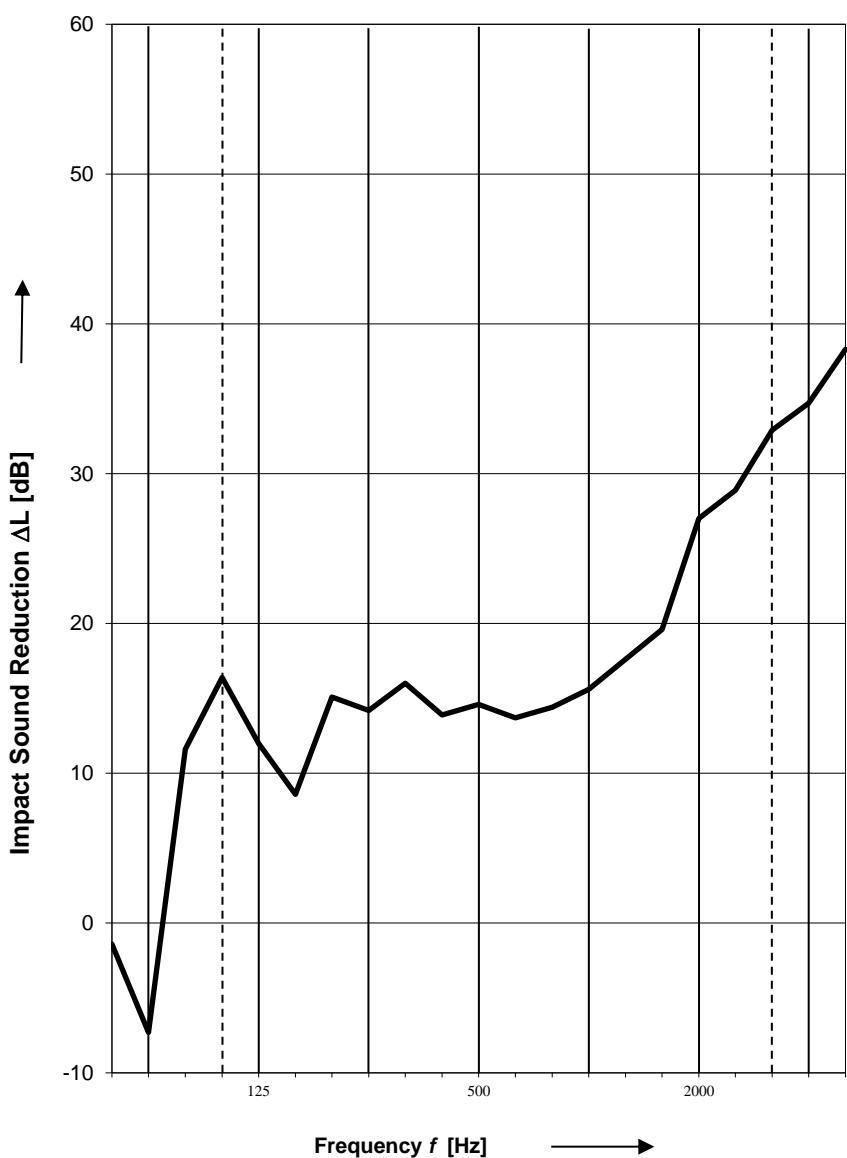
Evaluation according to ISO 717-2:

| $\Delta L_w =$ | 22 dB | $\Delta L_{IN} =$ | 13 dB |

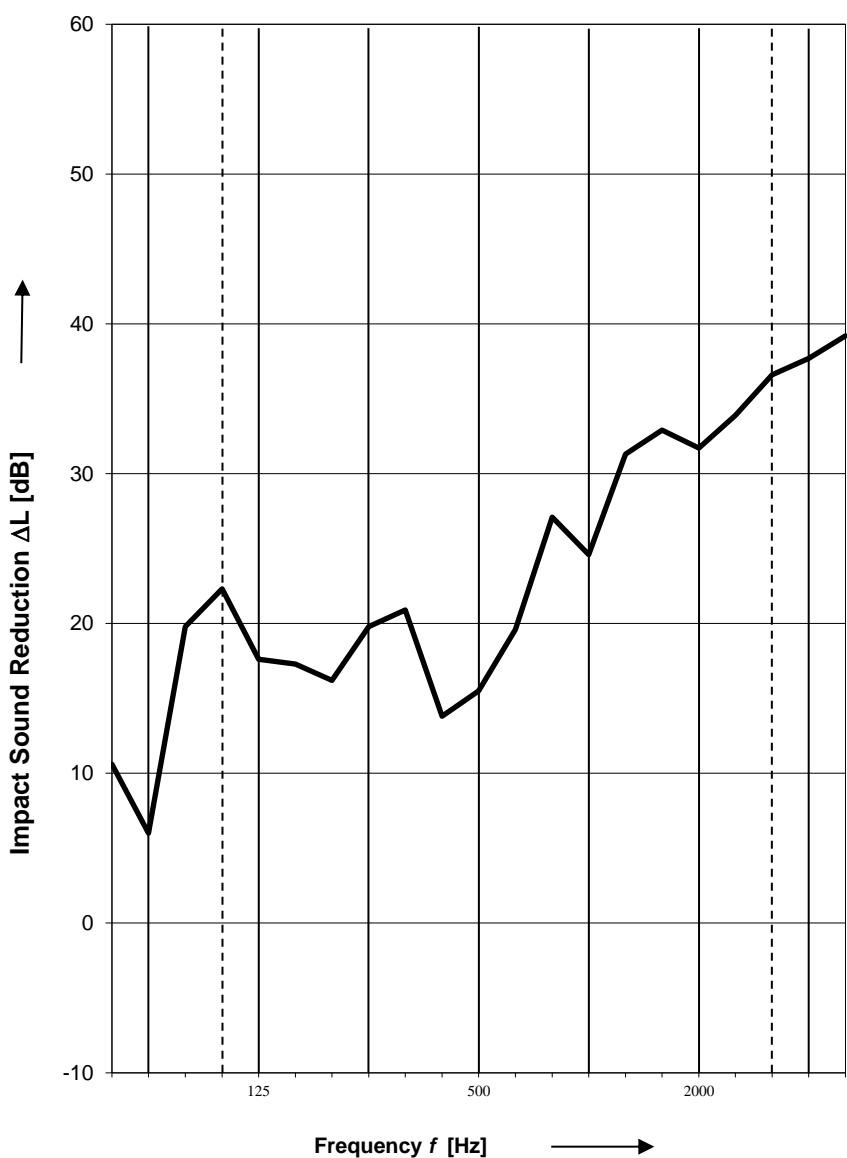
Evaluation according to ISO 717-2:

$$\begin{array}{ll} \Delta L_w = & 29 \text{ dB} \\ C_{I,\Delta} = & -11 \text{ dB} \end{array} \quad \begin{array}{ll} \Delta L_{IN} = & 18 \text{ dB} \\ C_{I,r} = & 0 \text{ dB} \end{array}$$

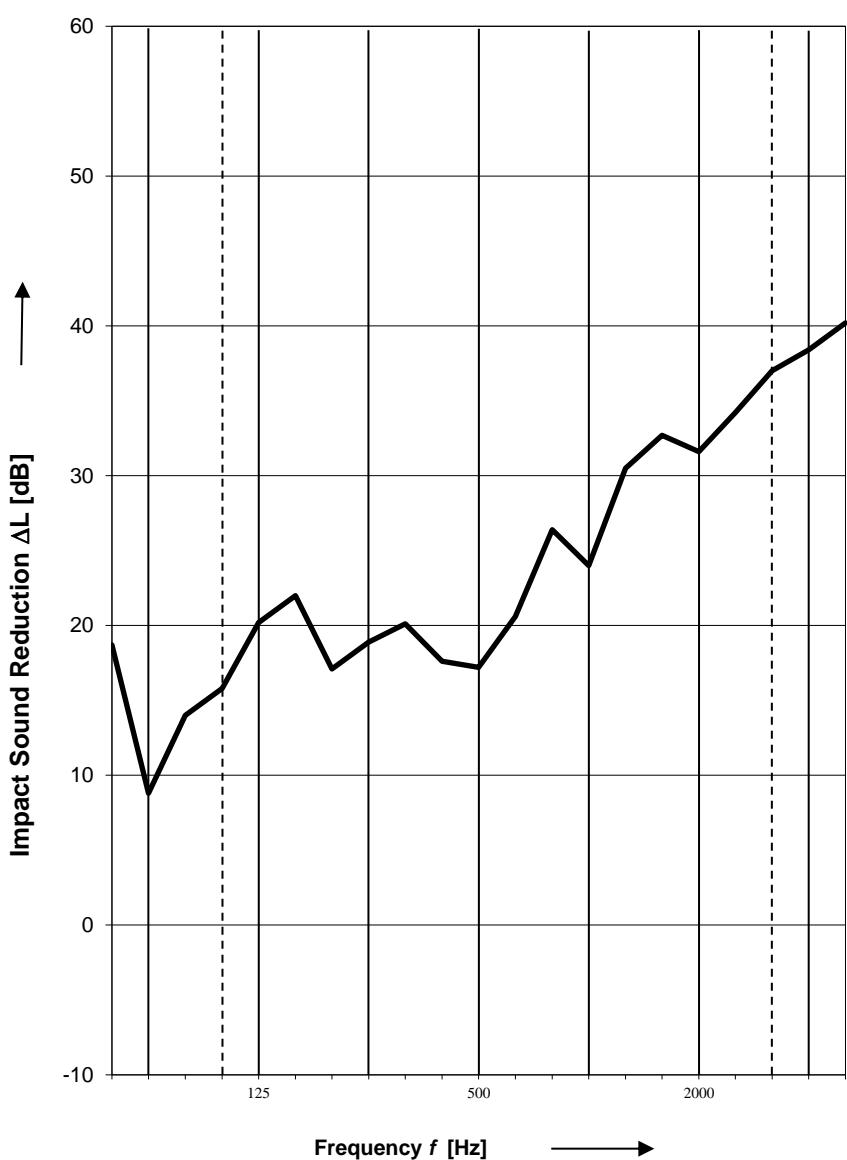
Evaluation according to ISO 717-2:

| $\Delta L_w =$ | 29 dB | $\Delta L_{IN} =$ | 19 dB |
