Technical Information BIS Yeti® Mountingsystem

Test Report
1762-001-19

- Impact Sound Reduction by Support Systems in the laboratory -

Test Object: BIS Yeti[®] Support Systems, type 480 or 335
with additional load, without or with EPS-insulation

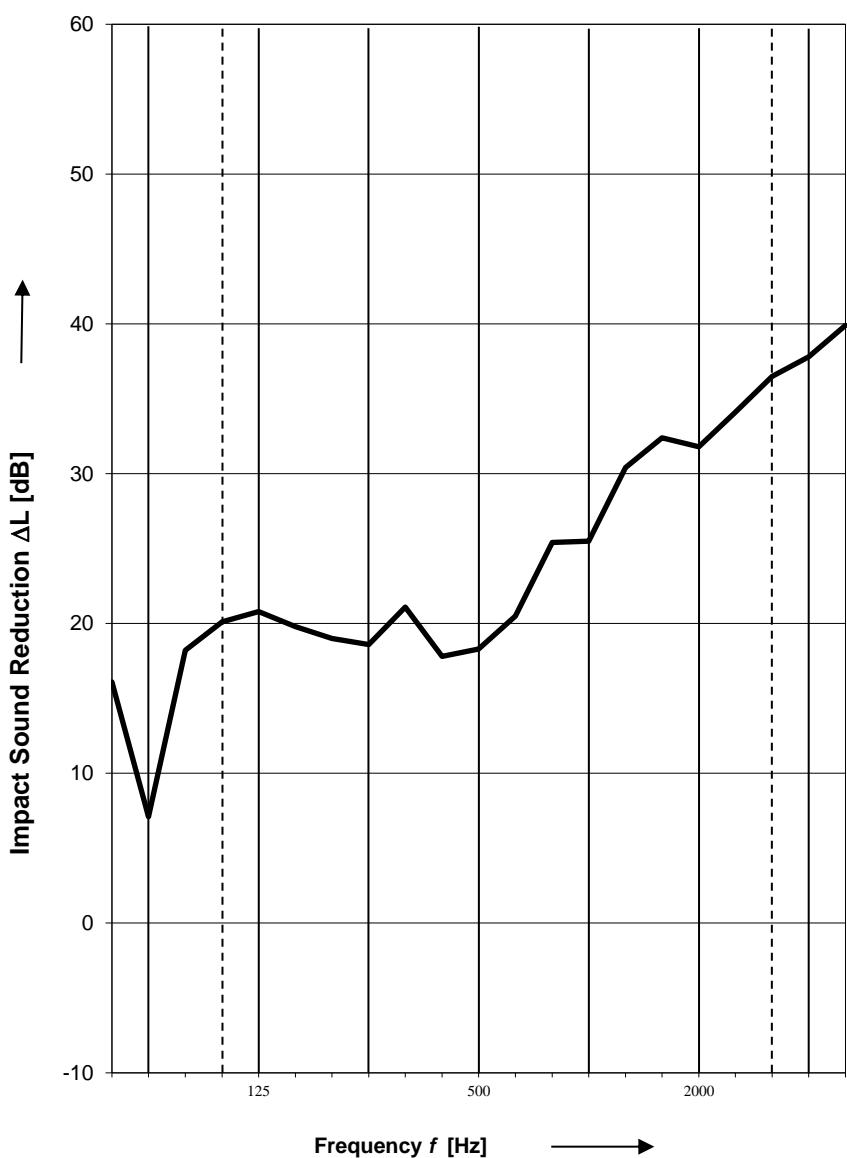
Evaluation according to ISO 717-2:

| $\Delta L_w =$ | 30 dB | $\Delta L_{IN} =$ | 20 dB |
